**A CASE STUDY ON STRENGTH EVALUATION OF STEEL CONNECTION ASSEMBLIES EMBEDDED IN PRECAST MEMBERS**

**James A. Attenhofer**, Clemson University, Clemson, SC  
**Tommy Mitchell, PE**, Tindall Corporation, Spartanburg, SC  
**Brandon E. Ross, PhD, PE**, Clemson University, Clemson, SC

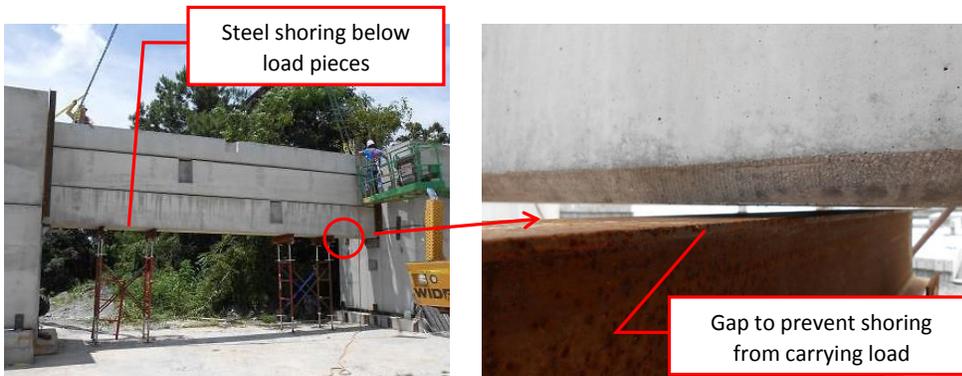
Figure 4 - Shoring below precast member during testing

Load pieces used were placed on the connections using a crane. The weights of the pieces were calculated using known member dimensions and concrete unit weight, and verified using a load cell on the crane. As a safety measure, steel shoring was placed below the load pieces during the loading process. Shoring was placed with a small gap below the load pieces so as to provide support in the event of a failure, but to not attract load during testing (Figure 4).

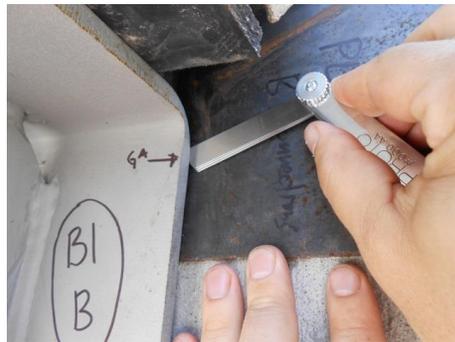
320 Figure 7 - Measuring gap behind gusset plate

305 | Attempts were made to evaluate the behavior of gusset plate assemblies (Figure 1Figure-1B)  
 306 by measuring the gap between the concrete surface and back of the connection plate. The  
 307 approach was to use steel plates of known thickness to measure the increase/decrease in the

308 | gap as the load was applied/removed (Figure 7). This approach was unsuccessful  
 309 because the steel plates were not precise enough to practically measure changes in gap size  
 310 under field conditions. Furthermore, in some members the gap could not be measured  
 311 because the back of the gusset was embedded in concrete. In the end, the evaluation team  
 312 decided to abandon gap measurements as a means of evaluation.
