EXPERIMENTAL TESTING OF 55-YEAR-OLD PRETENSIONED BRIDGE GIRDERS

ABSTRACT

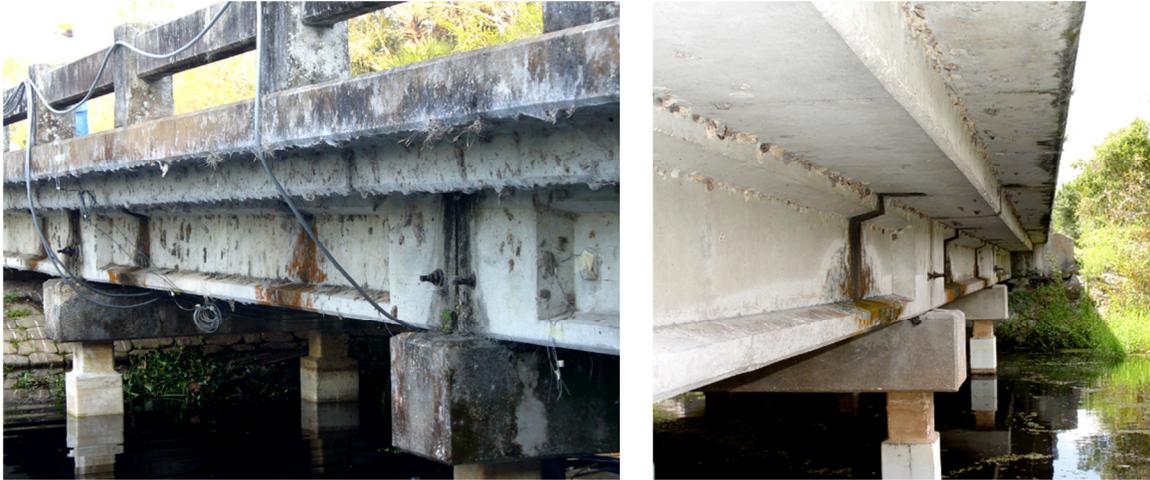
Figure 1–Existing bridge prior to girder removal.

The Florida highway system includes some of the earliest (circa 1950s) pretensioned concrete bridges in North America. Shear capacity of Florida's early pretensioned girders is of interest because the early designs had thin 102mm (4in.) webs and only limited vertical reinforcement. This paper presents the results of load testing of girders that were removed from an existing bridge (Figure 1) after nearly 55 years of service. Girders were approximately 7.6m (25ft) in length and supported a cast-in-place deck.

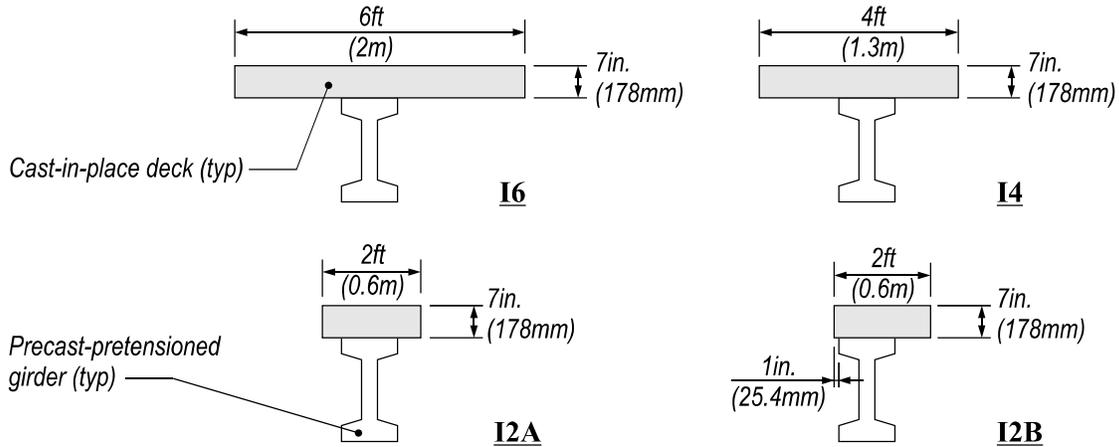
Slab approximately centered on girder except I2B

Figure 2–Test girder labels and slab configurations.

Each girder was given a unique label based on the width of the retained deck and position as an internal or external girder (Figure 2). Interior girders discussed in this paper were labeled with an 'I'. The numeric portion of each label indicates the nominal width of the slab in feet. For example, girder 'I6' was an interior girder with a nominal 6 ft (2 m) wide deck. Note that the dimensions for slab widths shown in Figure 2 are nominal dimensions and that the actual widths varied slightly along the length of the test girders.

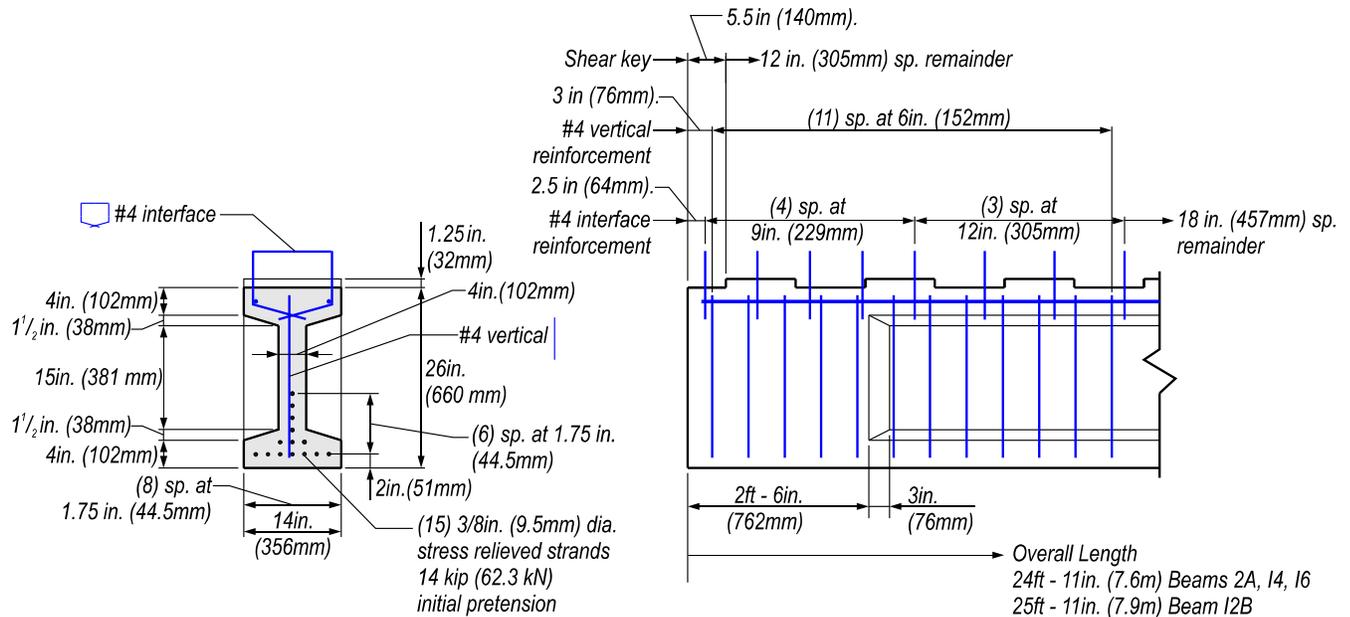
Figure 3—Girder cross section, reinforcement, and prestressing

Test girders were salvaged from a bridge on Highway SR-72, in Sarasota County, Florida, USA. Girders were precast and pretensioned, having the cross section, reinforcement, and prestressing shown in Figure 3. Additional details, including the original construction drawings from 1954 can be found in the FDOT report.

Construction drawings specified two continuous #4 longitudinal bars in the top flange and (12) #4 vertical bars spaced at 6 in. (152mm) at each end of the girders (Figure 3). The vertical bars did not have hooks specified. End blocks extended 2.5 ft (762mm) from each end. Non-destructive testing was used to locate the vertical bars in the web. Only two of the eight specimen ends had the specified number of reinforcement bars. Vertical reinforcement placement is discussed in section 4.

Drawings called for shear keys (Figure 3) on top of the girders to create composite action with the cast-in-place deck. Hoops were also specified to tie the girders and deck. The hoops were #4 bars partially embedded into the top flange, with the remaining portion extending above the girder and embedded into the deck. Drawings specified (24) hoops total for each girder, with 9 in. (229mm) spacing at the ends, and 18 in. (457mm) spacing near mid-span.

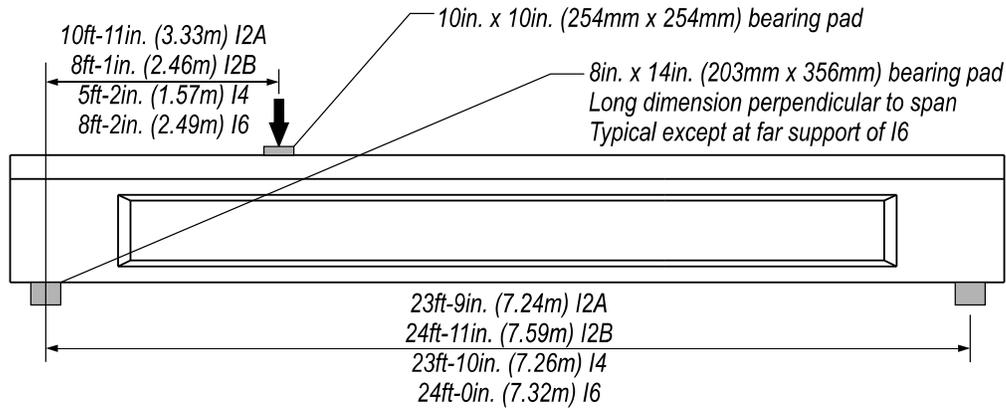
Figure 4—Test set-up.

Girders were load tested in three-point bending (Figure 4). Load was applied at rate of approximately 0.25 kip/second. A load cell was used to measure the applied load. Linear Variable Displacement Transducers, LVDTs, were used to measure vertical displacements at the load point and above each support. LVDTs were also used to measure strand slip at the end face of the girders. A steel frame was bolted to the end face to support the strand slip LVDTs. Strand slip was not observed during testing of the girders and is not discussed in this paper. Bonded foil strain gages were used to measure concrete surface strain and to detect cracks during testing.

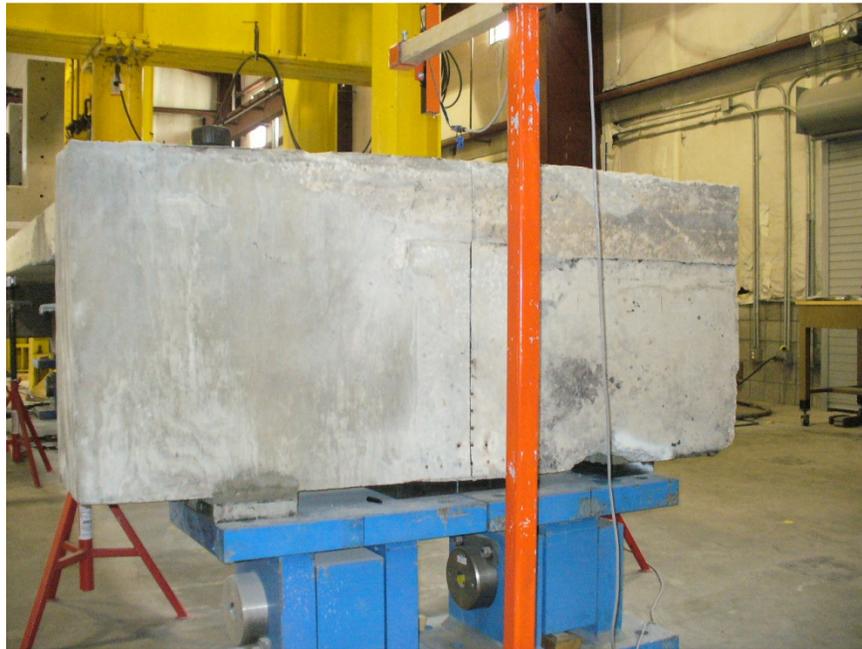
Figure 5—I6 far support.

Girders were supported at each end on reinforced elastomeric bearing pads. Additional bearing points were added at the far support of girder I6 to provide stability during testing. The additional bearing pads were placed below the end diaphragm as shown in Figure 5.

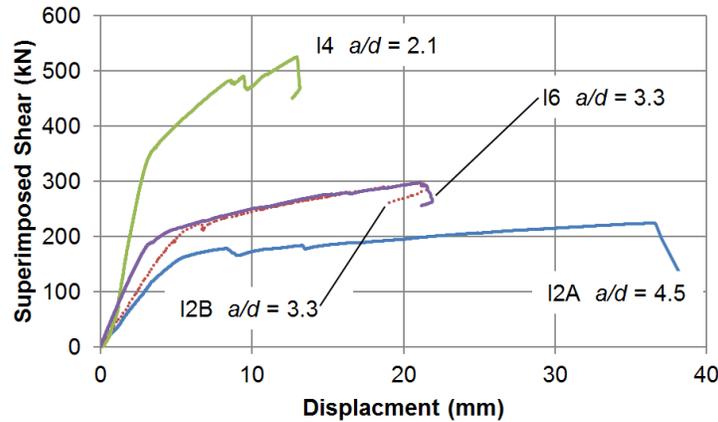
Figure 6–Shear vs. displacement.

Results of the load tests are presented in terms of superimposed shear (Figure 6). Superimposed shear is defined as the shear force at the near support due to the load applied by the hydraulic actuator. The superimposed shear does not include shear force due to girder self-weight. Displacement results are presented as the vertical displacement at the load point. Vertical deflection at the load point was taken as the average displacement recorded by the LVDTs on either side of the load point, less the displacement of the girders due to bearing pad compression at the reactions.

Specimen I2A was load tested at an a/d ratio of 4.5. The load-displacement behavior was linear-elastic until the superimposed shear reached approximately 120kN (27kip). Softening of the girder corresponded to the propagation of flexural cracks. The abrupt changes in the shear-displacement data (Figure 6) at displacements near 8mm and 13mm (0.3in and 0.5in) were due to the formation of inclined cracks in the web. Cracking in the web between the load point and the near support was particularly severe, as shown in Figure 7 and by the shading in Figure 8. As the load increased, additional cracks formed farther from the load point and at shallower angles.

Girder I4 was loaded at an a/d ratio of 2.1. Cracking was first observed in the web at a shear of 169kN (38kip) (Figure 10). Initial cracking had little effect on the girder stiffness as measured by the shear-displacement relationship (Figure 6). Stiffness of the girder changed at a shear of approximately 330kN (74kip) when an inclined crack formed at the web/end block interface by the near support. As load was increased additional cracks formed in the web on the far support side. The cracks formed farther from the load point and at shallower angles at higher loads. The abrupt changes in the shear-displacement plot near 9mm (0.35in) corresponded with formation of inclined cracks towards the far support. During the final stages of loading cracks in the web were approximately 12mm (0.5in) wide. As shear could not transfer across the cracks, and as the cracks did not engage transverse reinforcement, it is believed that the end of the girder towards the far support behaved as a tied arch during the final stages of loading. The peak superimposed shear supported by girder I4 was 525kN (118kip). Additional displacement would have resulted in failure of the truss and/or arch mechanisms; however it is unlikely that additional displacement would have resulted in loads in greater than the 525 kN (118kip) peak.

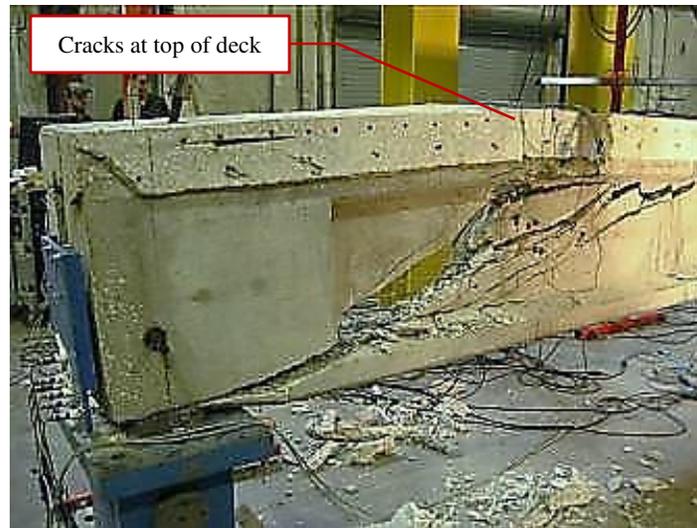
Figure 7–Failure of I2A

Failure was precipitated by the formation of tensile stress at the top of the arch (i.e. deck) between the near support and load point. Tension led to cracking at the top of the deck, which then caused the arch to become unstable and buckle upward (Figure 7). This type of failure has also been reported by Kostovos (1987). Failure occurred at a superimposed shear of 227kN (51kip).

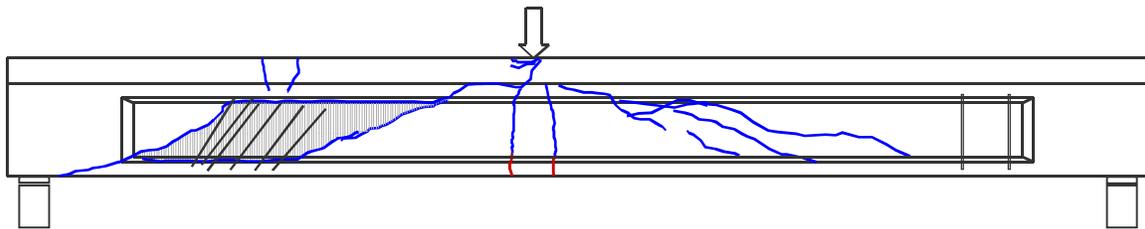
Figure 8–I2A cracks and damage (initial cracks in red)

Figure 8 shows the location of transverse reinforcement. Bars on the near support side of the load point were visible after cracking and were oriented as shown in the figure. The quantity of bars at the far support were determined non-destructively using a cover meter, however their orientation could not be determined. In absence of information on orientation Figure 8 shows the transverse reinforcement oriented vertically as specified in the original plans.

Cracks along the web-flange interface in the shear span prevented the transverse reinforcement from developing and carrying shear forces. On the far support side of the load, the cracks did not engage the transverse reinforcement. Incline cracks on both ends of the beam were too wide to allow force transfer by aggregate interlock. Without aggregate interlock and effective transverse reinforcement, the girder behaved as a tied-arch during the final stages of loading.

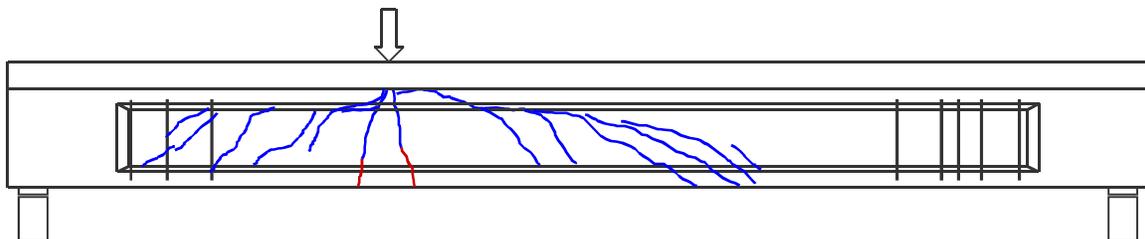
Figure 9–I2B crack pattern (initial cracks in red).

Girder I2B was loaded at an a/d ratio of 3.3, and behaved linear-elastically until the superimposed shear reached approximately 190kN (43kip), at which point flexural cracks formed below the load point (Figure 6, Figure 9). As additional load was applied, inclined cracks formed in the web and additional flexural cracks formed in the bottom flange. The peak shear of 298kN (67kip) corresponded to the formation of an inclined crack toward the far support.

Figure 9 can be used to compare the locations of cracks and transverse reinforcement. Reinforcement quantity and approximate location was determined through non-destructive evaluation, however the orientation shown in the figure could not be verified. From Figure 9 it can be observed that cracks between the load and near support intersected transverse bars whereas cracks towards the far support did not. As the cracks towards the far support were large, shear was not carried by aggregate interlock at that end of the beam. Thus it is believed that the near side of the girder supported load by some combination of arch and truss action, and the far side supported load by arch action. Additional displacement beyond displacement at peak load would have resulted in failure of the truss and/or arch mechanisms; however it is unlikely that additional displacement would have resulted in load larger than the observed peak.

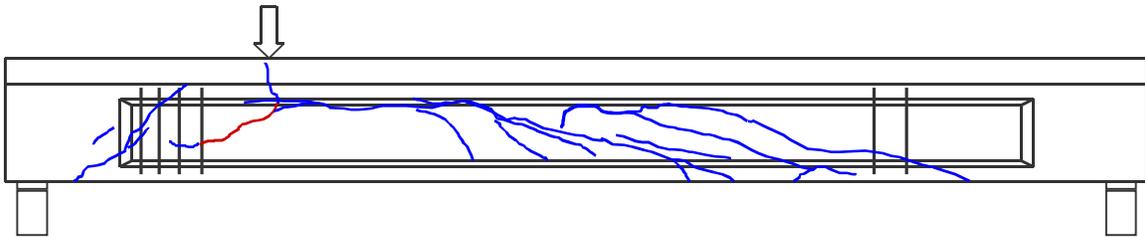
Figure 10–I4 cracks (initial crack in red.)

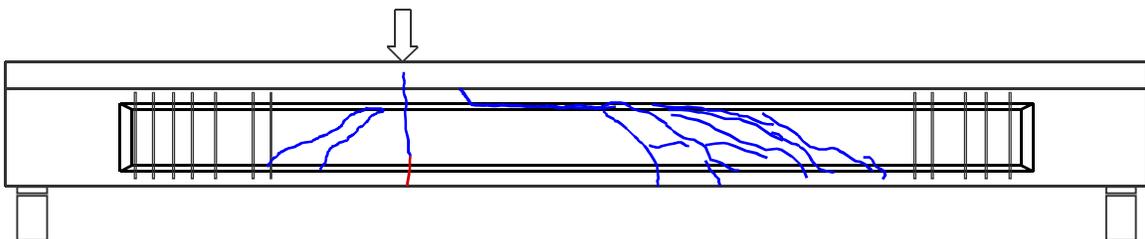
Figure 11–I6 cracks (initial crack in red.)

Girder I6 was loaded at an a/d ratio of 3.5. The girder behaved linear elastically until a flexural crack formed at a superimposed shear of 190kN (43kip) (Figure 6, Figure 11). Inclined cracks formed in the web toward the near support at a shear of 215kN (48kip). Shallower cracks formed farther from the load point as the load was increased.

The load test was terminated after a sudden drop in load caused by the formation of an incline crack at the far end of the girder. The maximum superimposed shear was 303kN (68kip). Cracks may have intersected transverse reinforcement at the near end, but not at the far end (Figure 10). Thus applied load was primarily carried by arch action during the final stages of testing. Additional displacement beyond the tested peak would likely have resulted in failure of the arch mechanism; however it is unlikely the additional displacement would have resulted in load greater than the observed peak.

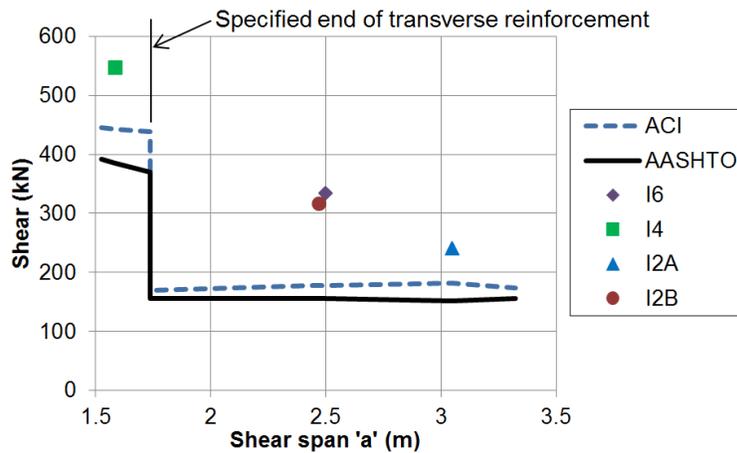
Figure 12—Experimental and theoretical shear capacities.

Figure 12 shows the code calculated nominal capacities plotted against the shear span length (a). The discontinuity at $a = 1.75\text{m}$ (5.7ft) occurs due to the specified termination of transverse reinforcement at that location. Point data on the figure represent the experiment shear capacity of the test girders. The experimental capacity of the girders was taken as the maximum superimposed shear plus the self-weight shear. In each case, the experimental capacities of the girders were greater than the theoretical capacities predicted by ACI and AASHTO codes. Data from Figure 12 is tabulated in Table 1. The experimental shear capacities were on average 1.66 and 1.79 times larger than the nominal capacities calculated by ACI and AASHTO, respectively.
