1
2
3
4
5 **EXPERIMENTAL EVALUATION OF BOTTOM FLANGE SPLITTING CRACKS**
6 **IN I-GIRDERS**
7

8 **Brandon E. Ross, PhD, PE**, Clemson University, Clemson, SC
9 **H.R. (Trey) Hamilton, PhD, PE**, University of Florida, Gainesville, FL
10 **Gary R. Consolazio, PhD**, University of Florida, Gainesville, FL
11

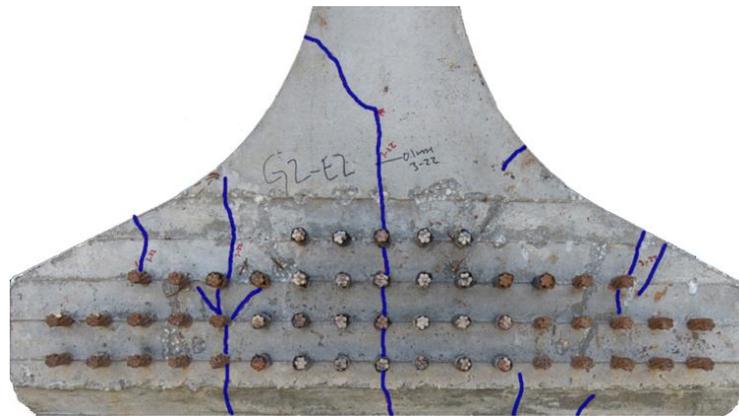
Figure 1–Flange splitting cracks (enhanced) in FIB girder.

48 FIBs are similar to girders used in other states, including NU girders in Nebraska² and WF
49 girders in Washington³. The FIB, NU, and WF girders each have bottom flanges that are
50 wider and more slender than comparable AASHTO girders. Wide bottom flanges can house
51 more prestressing strands and improve structural efficiency but can also be prone to splitting
52 cracks that typically form during or immediately following prestress transfer (Figure 1).
53

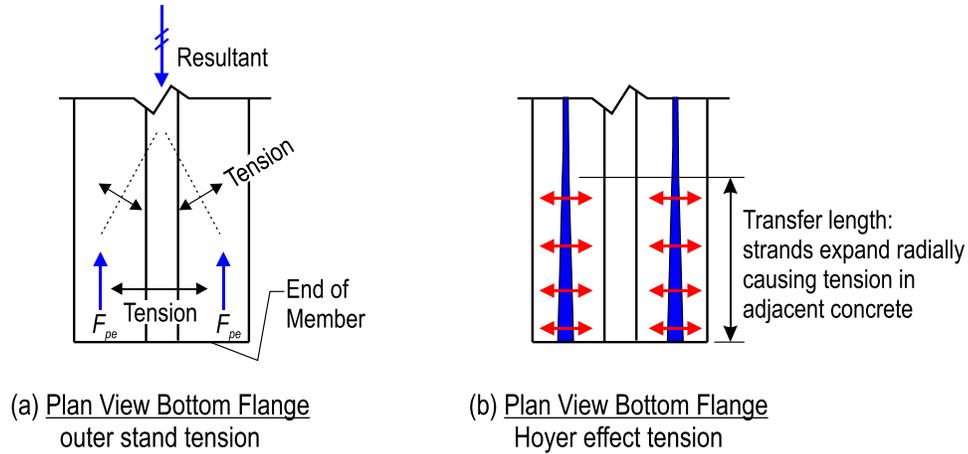
76
 77 Figure 2– (a) End tension due to outer strand eccentricity, (b) tension due to Hoyer effect.
 78

65 Previous research has demonstrated that flange splitting cracks form as a consequence of
66 concentrating fully bonded strands in the outer portion of the flange⁶. Such strand patterns
67 lead to transverse tension in the bottom flange (Figure 2a). Tensile stresses also occur due to
68 the Hoyer effect⁷ (Figure 2b). Strands contract radially during pretensioning due to Poisson
69 effect. During prestress transfer the strands within the transfer length expand towards their
70 former diameter but are partially restrained by the surrounding concrete. This restraint of

71 expansion creates tensile stresses in the concrete surrounding the strands. The superposition
 72 of tension stresses from eccentric prestressing force and Hoyer effect may lead to the
 73 formation of splitting cracks when these transverse stresses exceed concrete tensile capacity.
 74
 75

249 Significant bottom flange cracking occurred at the ends of specimens FB and FN, both of
250 which had fully bonded strands in the outer flange and partially shielded strands below the
251 web. Cracks at the end of specimens FB and FN are attributed to transverse tension at the
252 member end that formed due to the fully bonded strands in the outer flange (Figure 2a).

308 The longest flange cracks in the test program were approximately 30 in. in length. Transfer
 309 length calculated using LRFD provisions was 36 in. for the test specimens. Based on this
 310 comparison LRFD transfer length was comparable to the observed flange crack lengths and
 311 may be a reasonable guideline for placement of confinement reinforcement to control flange
 312 cracking. Correlation between flange splitting crack length and transfer length is attributed
 313 to the aggregate tensile stresses from the Hoyer effect and eccentricity of the strands in the
 314 outer flange (Figure 2).

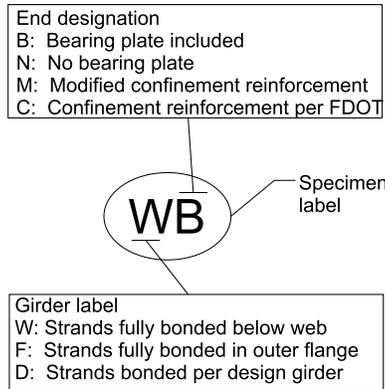
Figure 3—Labeling and graphical specimen descriptions.

112 Three 50-ft. long FIB-54 girders were built according to the schedule of variables shown in
 113 Table 1. Each end of each girder was detailed differently, resulting in six unique specimens.
 114 Girders and specimens were labeled using the convention shown in Figure 3. Figure 3 also
 115 presents graphical descriptions of each specimen.

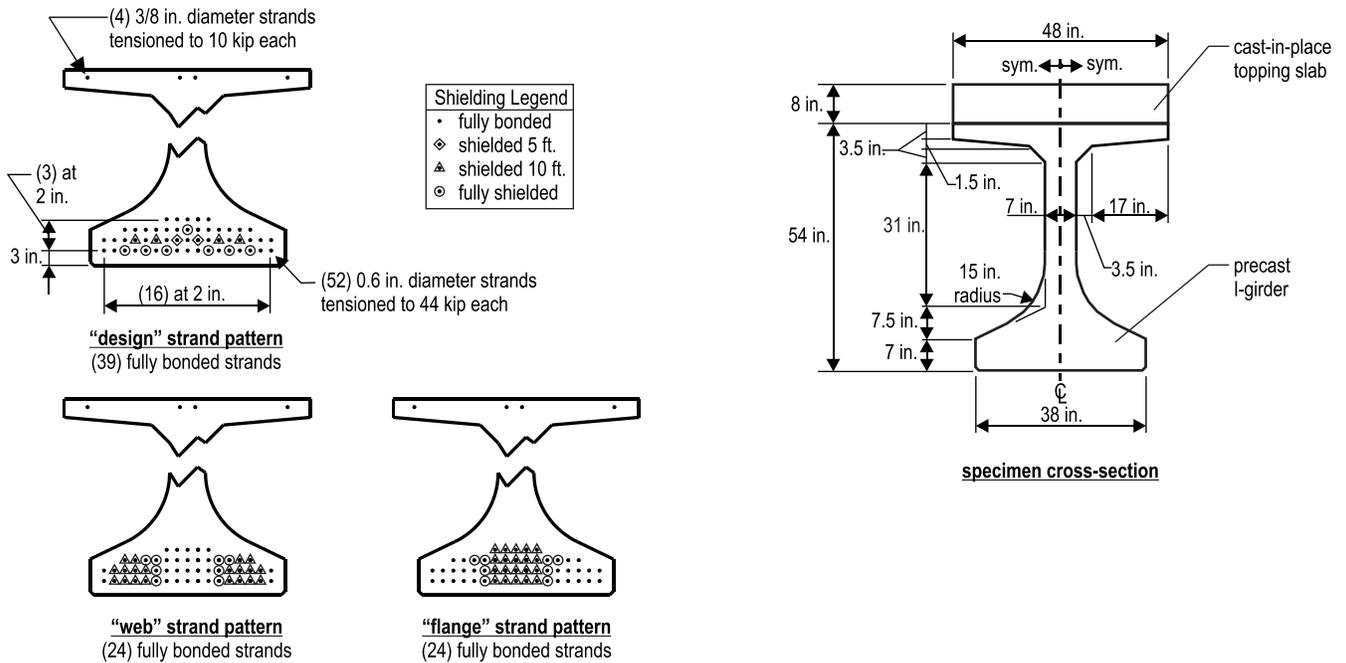
Figure 4—Prestressing and cross-section.

119 Essential specimen details are presented in Figure 4 and Figure 5, and tested material
 120 properties are listed in Table 2. A comprehensive discussion of details, construction
 121 procedures, materials properties, and construction events is presented by Ross et al.¹². Test
 122 variables are discussed in the subsequent paragraphs.

137 **Strand bond pattern.** Previous research has demonstrated that strand pattern can affect the
138 occurrence of flange splitting cracks, and that patterns with fully bonded strands concentrated
139 in the outer flange are particularly problematic⁶. Three different patterns were used in the
140 test program. The “design” pattern was selected to match a pattern used on an actual girder
141 design. The design pattern had (39) fully bonded strands. The “web” and “flange” patterns
142 had (24) fully bonded strands and were designed to evaluate the effects of concentrating fully
143 bonded strands below the web and in the outer flange. The “web” and “flange” patterns
144 violated LRFD requirements for quantity and placement of strand shielding, but were useful
145 for evaluating extreme conditions. Fully shielded strands were used in the “web” and
146 “flange” patterns to allow each of the specimens to be constructed simultaneously on the

267 Length and area of the bottom flange cracks are quantified in Figure 10. Cracking was most
 268 severe in specimen FN, having 105% greater length and 115% greater area than the averages
 269 of all specimens. Severity of cracking in FN is attributed to the “flange” strand bond pattern
 270 (Figure 4) which placed fully bonded strands in the outer flange. Absence of a bearing plate
 271 is also believed to have had negative affect on cracking in specimen FN.
 272
 273

277 Specimen FB had the second greatest degree of flange splitting cracks. FB had an embedded
 278 steel bearing plate and utilized the “flange” strand bond pattern (Figure 4). Specimen FB had
 279 40% less cracking by length and 43% less cracking by area than FN. Reduced cracking in
 280 FB, relative to FN, is attributed to the confining effect of the bearing plate.
 281

288 Specimens DC and DM utilized the “design” strand bond pattern, which included (39) fully
 289 bonded strands distributed throughout the bottom flange (Figure 4). The other specimens had

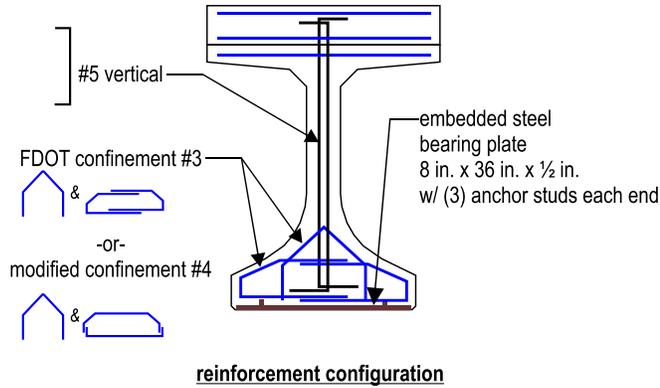
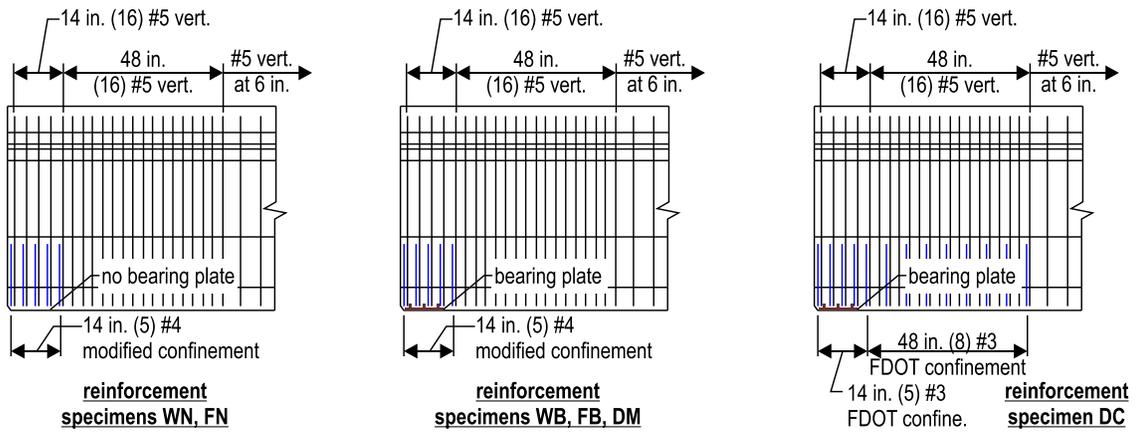
Figure 5—Mild reinforcement and bearing plates.

133 **Bearing plates.** Presence/lack of steel bearing plates was included as a variable to evaluate
134 the effect of bearing plates on flange splitting cracks. Plates were anchored to the bottom of
135 girders using headed studs.
136

149 **Confinement reinforcement.** LRFD standards require that #3 confinement reinforcement
150 encompass prestressing strands for $1.5d$ from member ends. Building on previous research
151 which demonstrated that forces in confinement reinforcement are greatest near member
152 ends¹³, a modified confinement detail was used in five of the six specimens. The modified
153 detail utilized #4 bars and concentrated all confinement reinforcement within 16 in.
154 (approximately $0.3d$) of the member end. Specimen DC did not use the modified detail but
155 had #3 bars spread over a greater distance from the end.
156

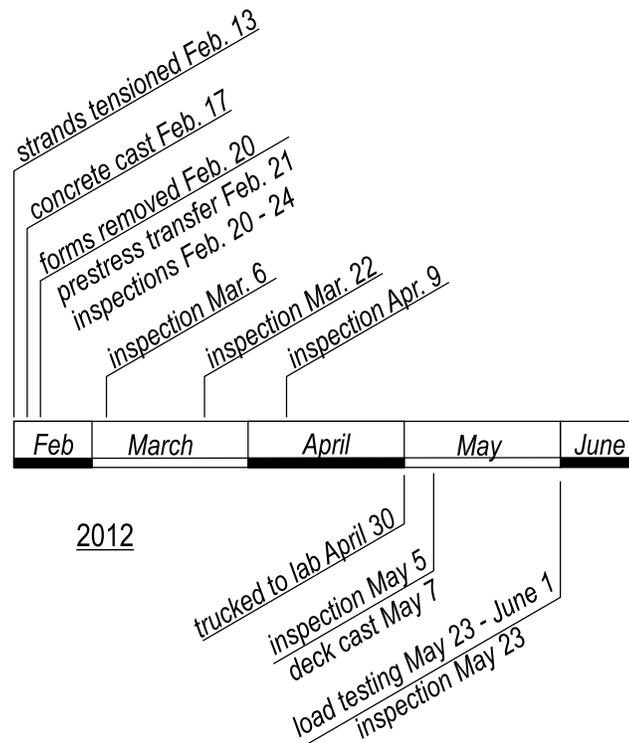
Figure 6 – Fabrication and inspection timeline.

157 Girders were built by Standard Concrete Products of Tampa, FL according to the timeline in
158 Figure 6. This figure also lists inspection and testing dates. Load tests are reported by Ross
159 et al.¹². Girders were constructed simultaneously in the same stressing bed and using the
160 same materials. Concrete for the girders was a self-consolidating mix that was batched at the
161 precast facility. Prestress force was transferred by flame cutting the strands (Figure 7) three
162 days after casting. Strands in production girders fabricated at the plant are typically cut
163 sooner than three days. The additional time before strand cutting was needed to install
164 research instrumentation. Cuts were made simultaneously along individual strands at
165 locations between girders and at the ends of the stressing bed. The cutting sequence was
166 outside-in and top-to-bottom. Fabrication and quality control procedures were typical of

Strain and crack data were collected during and in the months following prestress transfer. Strain data are not discussed in this paper but are presented in Ross et al.¹². Crack data were collected by visual inspection on the dates shown in Figure 6. Visual inspections included marking cracks with a crayon and documenting locations and lengths by tape measure and photograph. Crack widths were measured at one or two locations along each crack using a microscope that was precise to +/- 0.001 in.

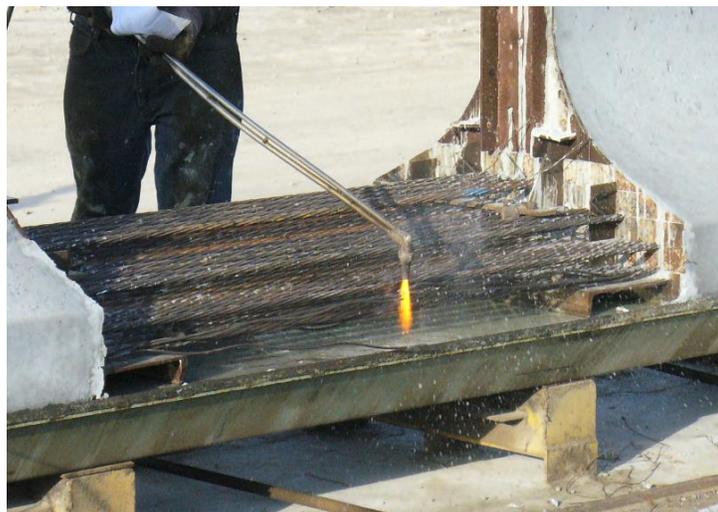
Figure 7 – Prestress transfer by flame cutting strands. Specimens were built simultaneously on the same prestressing line.

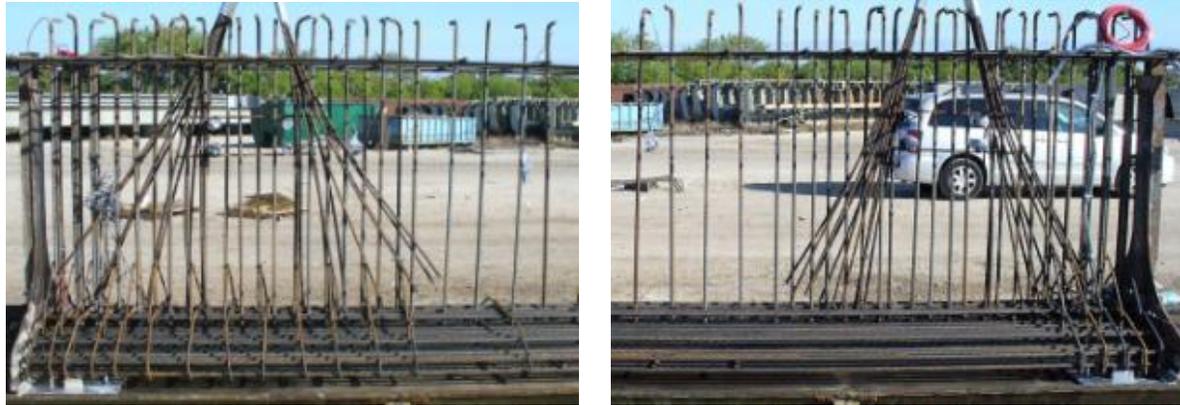
Figure 8 - Reinforcement for specimen DC (left) and specimen DM (right). Specimen DM had more confinement reinforcement (by cross sectional area) near the end. Specimen DC had more confinement reinforcement overall.

167 FDOT projects. Figure 8 shows specimens DC and DM. Specimen DC had confinement
168 reinforcement based on FDOT standards; specimen DM had modified confinement
169 reinforcement.
170

315
 316 Effects of confinement configuration can be compared using results from specimens DC and
 317 DM. Specimen DC had #3 confinement reinforcement distributed over 64 in. from the end.
 318 DM had #4 confinement reinforcement but had fewer total confinement bars than DC. All

319 of the confinement reinforcement in DC was placed within 16 in. of the member end.
320 Specimen DC had 2.5 times more flange cracking by length and 2.1 times more flange
321 cracking by area than did specimen DM. Thus the modified confinement reinforcement
322 performed better at controlling flange splitting cracks than did the FDOT configuration. This
323 is attributed to the fact that specimen DM had a greater area of reinforcement placed closer to
324 the end. Although the modified reinforcement scheme was more effective in controlling
325 flange cracks it did not perform as well as the FDOT scheme in load tests¹². Specimen DM
326 with modified confinement had 7% less shear capacity in load tests than did DC.

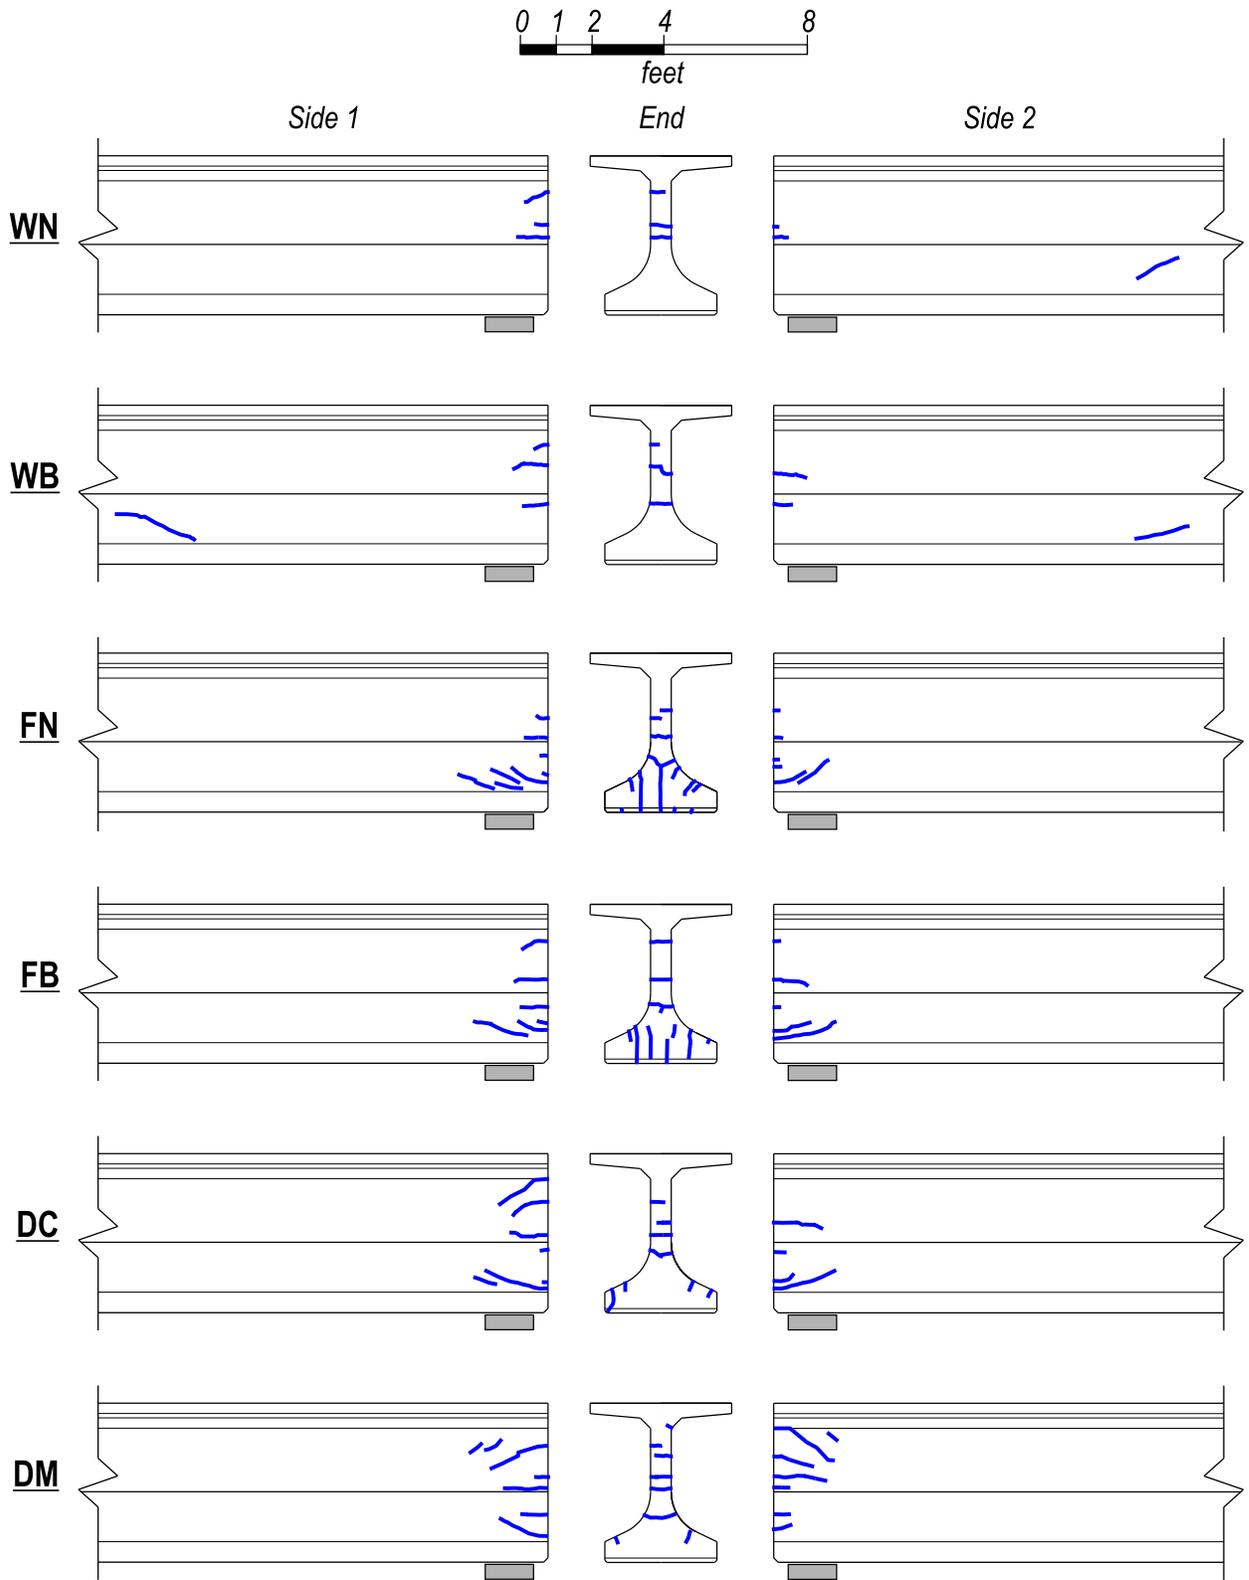
Figure 9 – Web and flange splitting cracks. Flexural cracks in the top flange are not shown.

228 Web and flange cracks are shown in Figure 9. Flange splitting cracks are of primary interest
229 in this paper and are discussed in the following paragraphs. Top flange flexural cracks and
230 web splitting cracks are not discussed in this paper, but are addressed in the author's report
231 for the FDOT¹².

233 Flange splitting cracks were first observed during prestress transfer. Cracks grew in width,
234 length and in quantity in the days and weeks following prestress transfer. Figure 9 shows the
235 web and flange cracks in each specimen three months after prestress transfer. Additional
236 cracks were observed on the bottom of surface of each specimen. The bottom surfaces of the
237 specimens were inspected after placement of the specimens on dunnage in the storage yard at
238 the precast facility. The width, length, and location the bottom surface cracks were roughly
239 equivalent to cracks observed on the top surface of the bottom flange.

241 Locations of cracks shown in Figure 9 can be understood by considering the strand bond
242 pattern associated with the test specimens. For example, specimens WN and WB had flange
243 splitting cracks located 10ft from their ends. These cracks formed within the transfer length
244 of the partially shielded strands and were likely due to the fact that nearly all of the strands in
245 the outer portion of the flange were debonded up to this point (Figure 4). Cracks then formed
246 due to transverse tensile stresses and Hoyer stresses from the transfer of a large prestress
247 force over a relatively short distance.

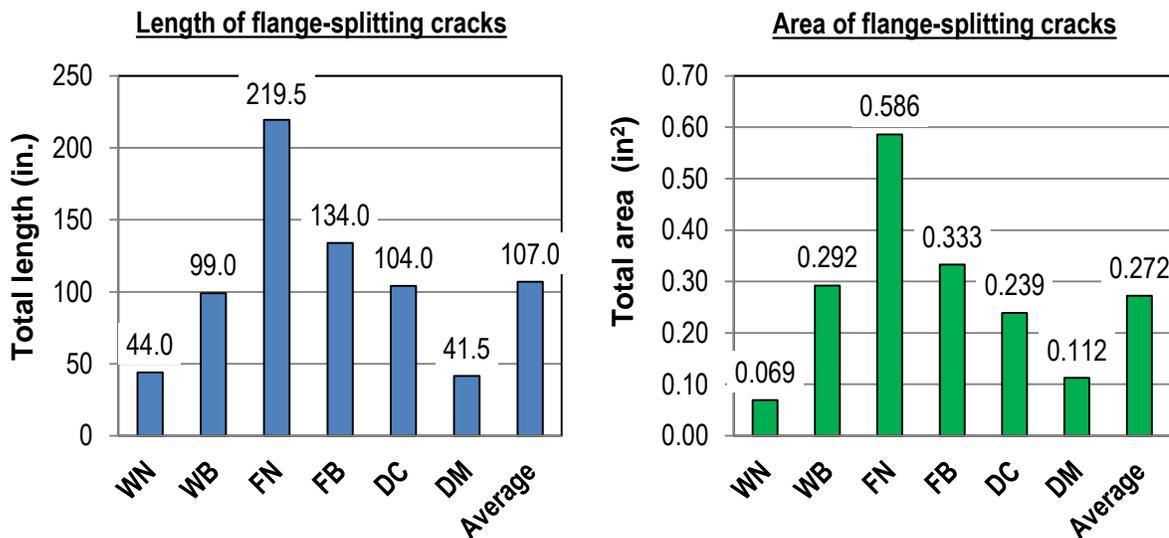
274
 275 Figure 10–Flange splitting cracks.
 276

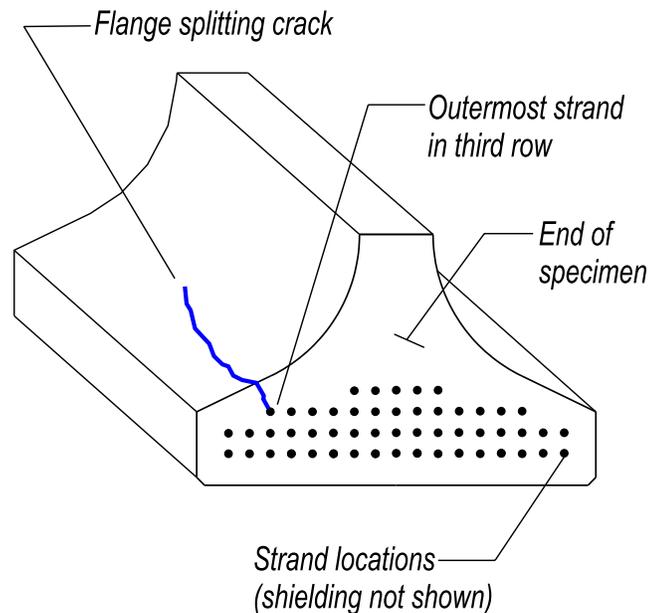
Figure 11—Flange splitting crack at outermost strand.

294
 295 A crack intersected the outermost strand in the third row in each of the specimens. The
 296 strand at this location had only 2.5 in. of clear cover, the least amount of cover of any strand
 297 in the test specimens. In specimens WN and WB cracks at this strand occurred 10ft away
 298 from the end where shielding for the strand terminated. In all other specimens the crack
 299 formed at the member end (Figure 11). It is recommended that this location be avoided when
 300 designing strand patterns in FIB girders.

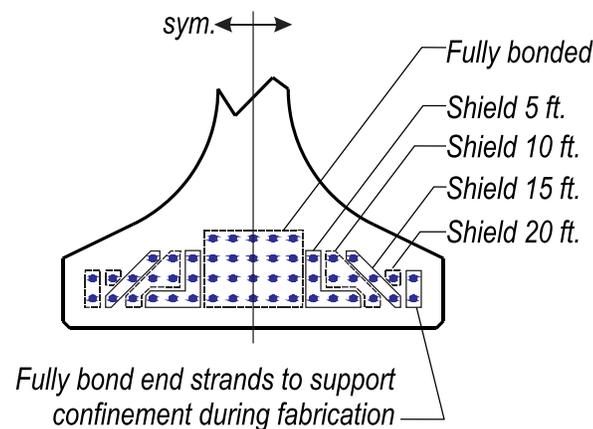
Figure 12–Recommended strand shielding pattern for future research

363 The strand shielding pattern shown in Figure 12 combines the beneficial aspects of the ‘web’
 364 and ‘design’ strand patterns. Similar to the ‘web’ pattern, fully bonded strands in Figure 12
 365 are placed concentrically in the bottom flange, and thus will not lead to end tension
 366 associated with eccentric outer strands (Figure 2a). Cover distance over of the fully bonded
 367 strands will provide confinement and assist in controlling cracking due the Hoyer effect
 368 (Figure 2b). Similar to the ‘design’ pattern, termination locations of strand shielding are
 369 staggered, and the likelihood of flange cracks at the termination locations will be small. In
 370 addition to reducing the likelihood of flange cracking, it is also believed that the pattern in
 371 Figure 12 has advantages from a strength perspective. For example, the fully bonded strands
 372 below the web can act as longitudinal tie reinforcement without contributing to lateral-
